# **The Effects of Copper Contamination on the Properties of High Density Polyethylene**

**C A Scoggins, P E Tomlins and M Bevis\***

**Centre for Materials Measurement and Technology  
National Physical Laboratory  
Teddington, Middlesex  
United Kingdom, TW11 0LW**

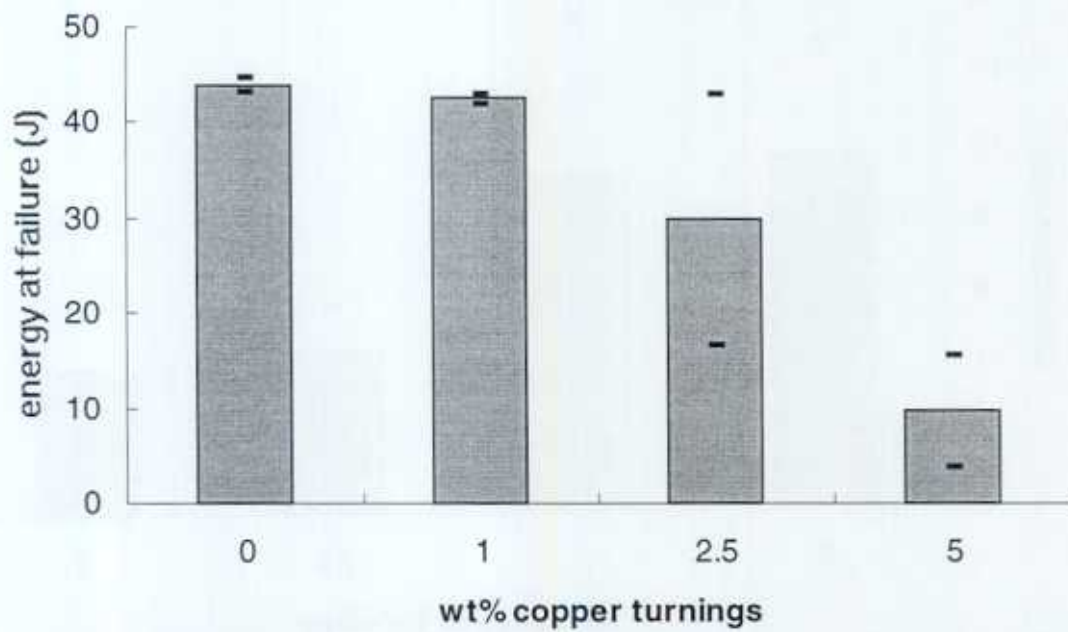
**Figure 9: Falling weight impact energy (-70°C)**

Figures 7, 8 and 9 show the impact energies of virgin and copper contaminated HDPE obtained at different temperatures. Contamination has no significant effect on impact energy at 25 and 0°C. However there is some indication that high levels of contamination reduce impact energy at -70°C. Note that the impact energy of virgin HDPE progressively increases with reduction in temperature. This is particularly noticeable between 0 and -70°C. An examination of the specimens showed that

the lower impact energies were caused by the presence of one or more copper particles near the impact site, as the test-piece had split around these inclusions instead of the striker simply puncturing the specimen.

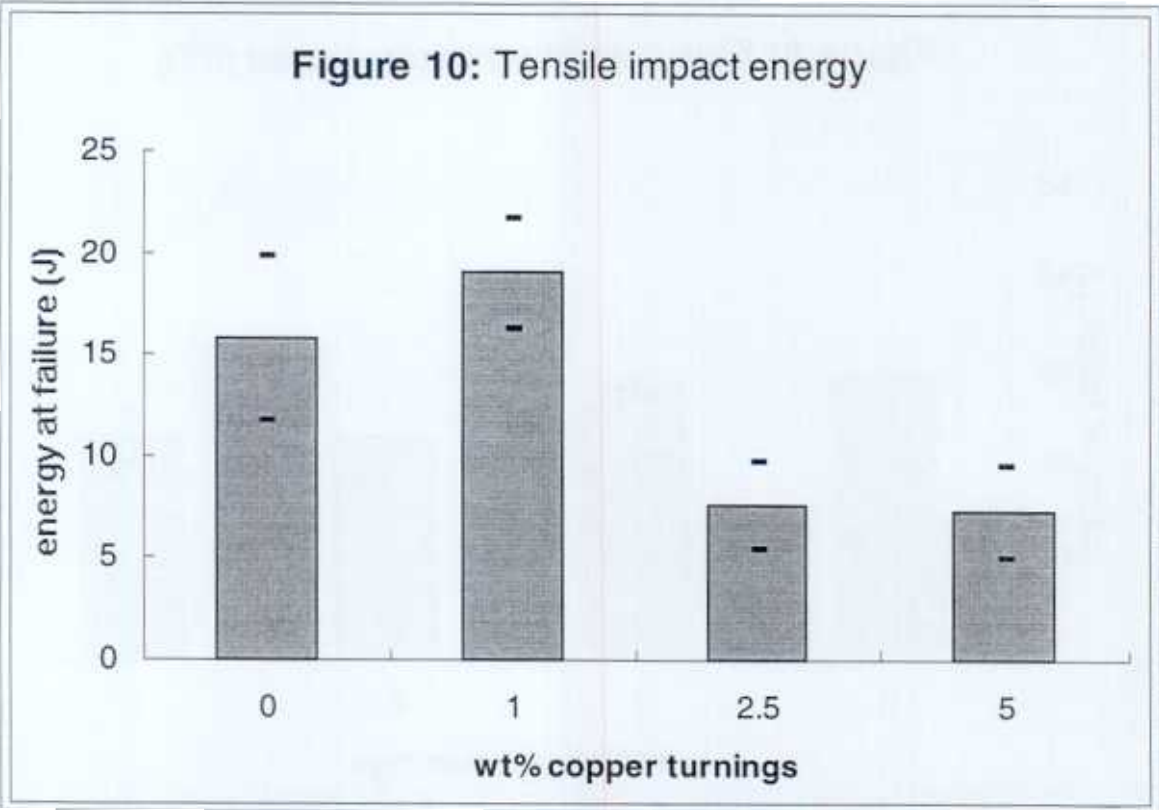
The tensile impact energies (Figure 10) and deflection at failure (Figure 11) decrease with increasing concentration of contaminant. However the scatter of results in the less contaminated specimens shows the test is sensitive to specimen surface quality. A small nick or defect in the specimen edge can act as a stress concentrator when subject to tensile shock loads, causing premature failure of the specimen. Measurements made using specimens with smoothed edges did reduce the scatter of results but the time and effort involved in smoothing the specimens far outweigh the improvements gained. An examination of the fracture surfaces showed that specimens with less contamination exhibited classic ductile fracture. The copper particles did not appear to adhere to the HDPE matrix, but simply reduced the effective cross sectional area of the specimen causing premature failure, although still in a ductile mode. The surface sensitivity of the test makes it difficult to distinguish which of the results might be due to contamination or a specimen surface defect.
