# **An Evaluation of Tests for the Adhesion of Thermal Barrier Coatings**

**S R J Saunders, J P Banks and  
C Chunnillall**

**September 2001**

National Physical Laboratory  
Teddington, Middlesex TW11 0LW, UK

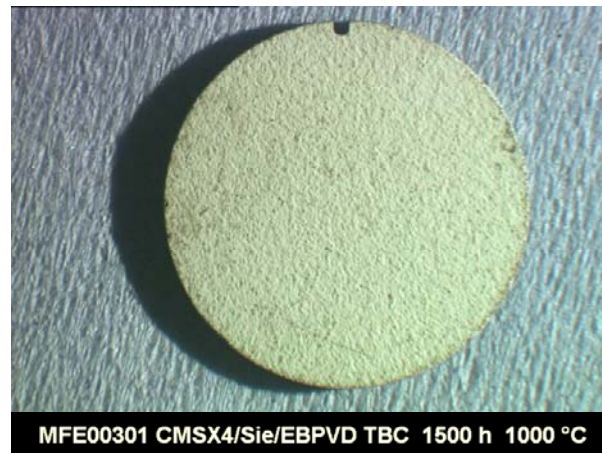
*Figure 15*      *Optical micrograph of a typical test sample for the piezospectroscopic investigation showing relocation notch.*

Figure 15 is a micrograph of the sample shape used showing a notch that was used for relocation. Figures 16 - 18 show cross-sections of some of the as-received samples (IN738/2453/APS, CMSX4/2453/EB-PVD and CMSX4/RT22/EB-PVD, respectively). It will be seen that the Sicoat 2453 was about 220-250  $\mu\text{m}$  thick, the APS about 250  $\mu\text{m}$  and the EB-PVD about 100  $\mu\text{m}$ . Figures 19 and 20 are cross-sections through aged samples showing the TGO that developed on Sicoat 2453 and RT22 respectively.

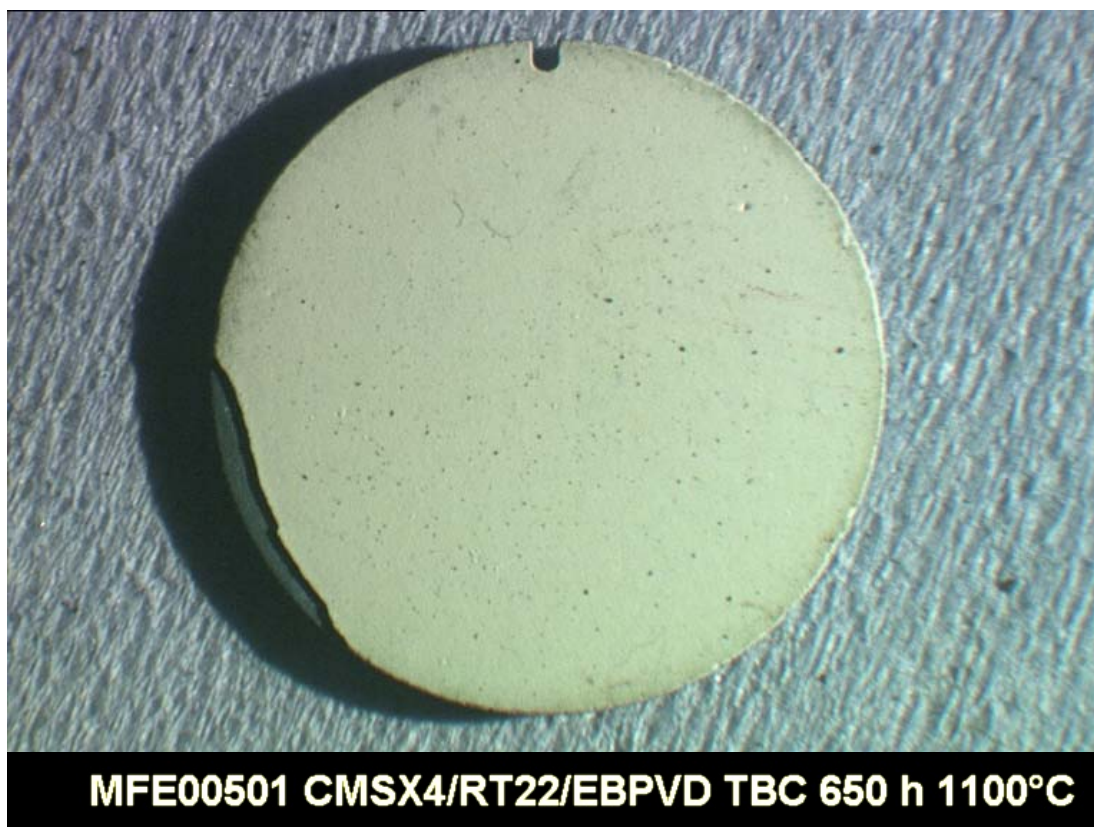
*Figure 31*      *Optical micrograph of CMSX4/RT22/EB-PVD aged for 650 h at 1100 °C with the slow cool cycle*
