## **Evaluation of Techniques for Measuring the Corrosion Activity of Carbon Steel Welds**

W Nimmo, A J Griffiths, L Orkney, A Mensah and A Turnbull  
Materials Centre  
National Physical Laboratory  
Teddington, Middlesex TW11 0LW, UK

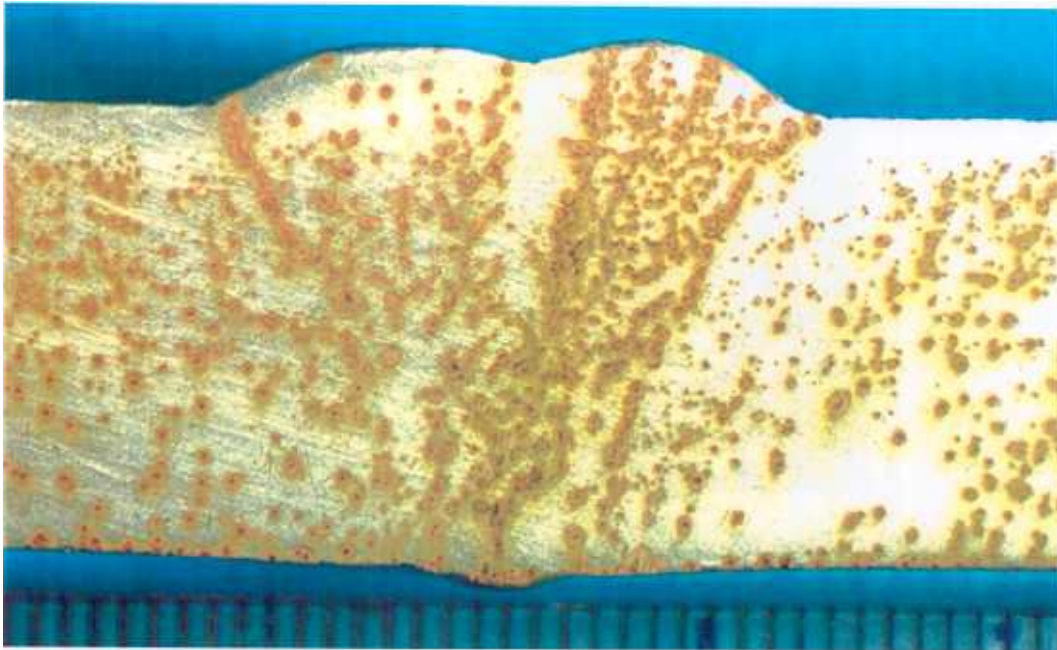
**Figure 5. Visual appearance of weld Y after exposure to distilled water for 60 minutes showing corrosion at discrete anodes.**

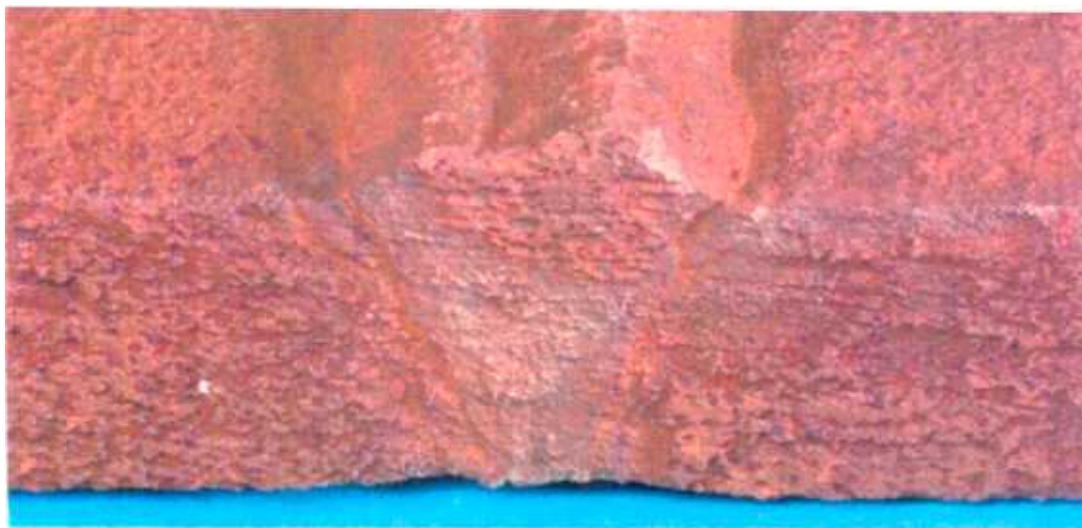
Figure 19. Appearance of weld Z after 21 days galvanostatic testing showing shallow groove at boundaries between the weld and the parent plate.

The appearance of the specimens after applying a current density of  $0.88 \text{ mA cm}^{-2}$  for 21 days is shown in Figures 17-19. Weld X (1% Ni consumable, 3-4 mm root gap) showed a preferentially high corrosion rate in the boundary between the weld and the parent plate and to a lesser degree in the parent plate in an area near the weld (Figure 17). A fine groove could be seen along the edge of the weld bead of the final pass running perpendicular to the plane of the paper in Figure 17. Examination of weld Y (Ni-free consumable) indicated significant corrosion of the weld with a pronounced step across the boundary with the parent plate (Figure 18). The weld passes can be seen as ridges in the section of the weld metal. Weld Z (1% Ni consumable, no root gap) showed preferential removal of material in the boundary between the weld and the parent plate (Figure 19), as for weld X (1% Ni consumable, 3-4 mm root gap). More detailed examination indicated that within this region of attack, shallow grooves ran parallel to and on either side of the weld root. This was not as clearly observed in the immersion tests on this weld. A similar effect was seen at the weld cap. Hence, there would appear to be no significant influence of autogenous welding on corrosion susceptibility as concluded previously.

The hardness of controlled weld Z (1% Ni consumable, no root gap) shows the characteristic peaks associated with the hardened HAZ on both sides of the weld (Figure 26) and these areas were found to corrode preferentially (Figure 19) reinforcing the suggestion that higher hardness indicates corrosion susceptibility. The hardness profile for controlled weld Y (Ni-free consumable) shows that the weld metal and parent plate are of similar hardness separated by very pronounced hardness peaks in the HAZ (Figure 25). In this case the hard areas do not correlate with those that corroded preferentially. In this case the area of lowest hardness, the weld metal, corroded preferentially which is the reverse of the findings for welds X and Z.
