# **Compatibility of Lead-free Solders with PCB Materials**

**Miloš Dušek, Jaspal Nottay and Christopher Hunt**

**August 2001**

Materials Centre  
National Physical Laboratory  
Teddington, Middlesex, UK, TW11 0LW

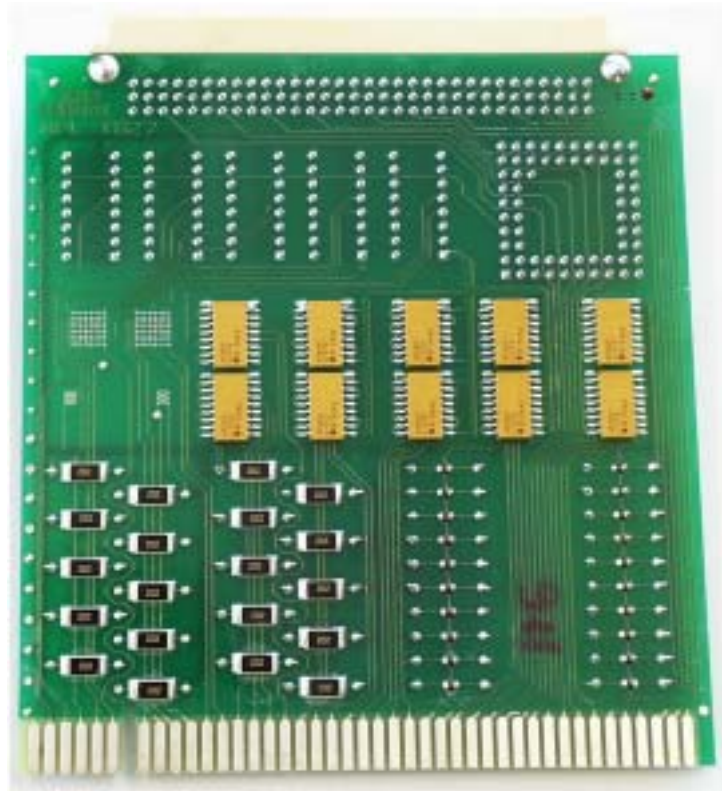
Wave soldered PCB

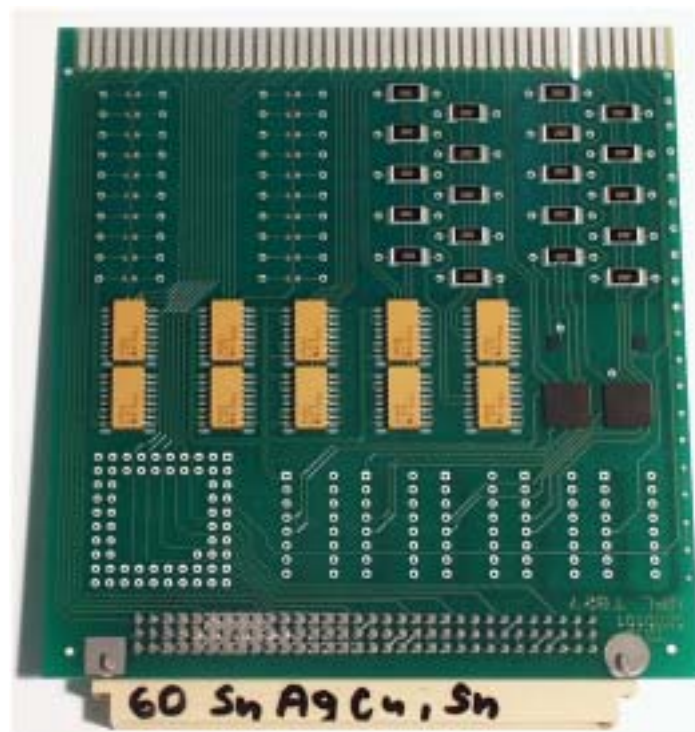
PCB with placed components for reflow soldering

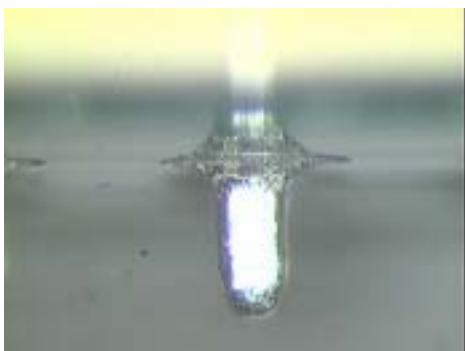
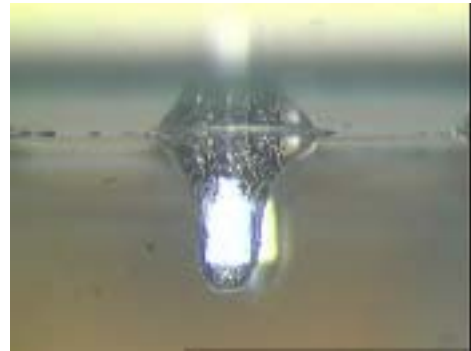
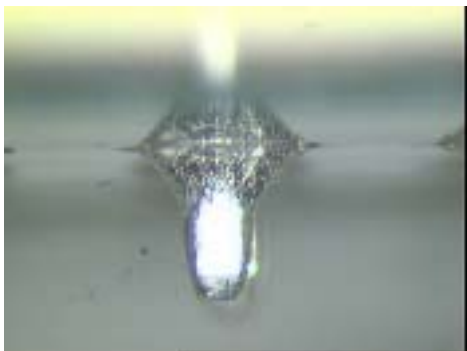
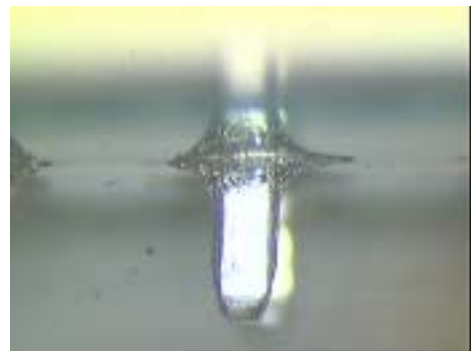
The photographs below present side views of the intrusively reflowed solder joints. The letters indicate the positions on the connector. No crack-related failures caused by accelerated thermal cycling (to 2200 cycles) were detected using electrical continuity testing.

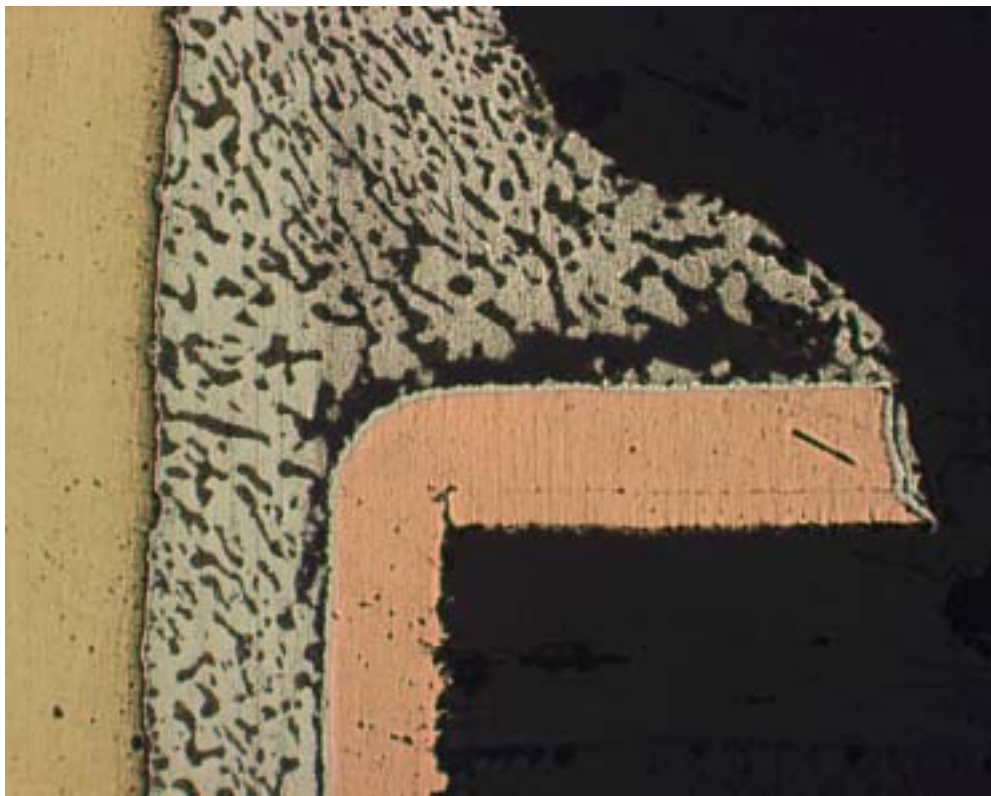
Fillet of SnPb / Cu after 2200 cycles

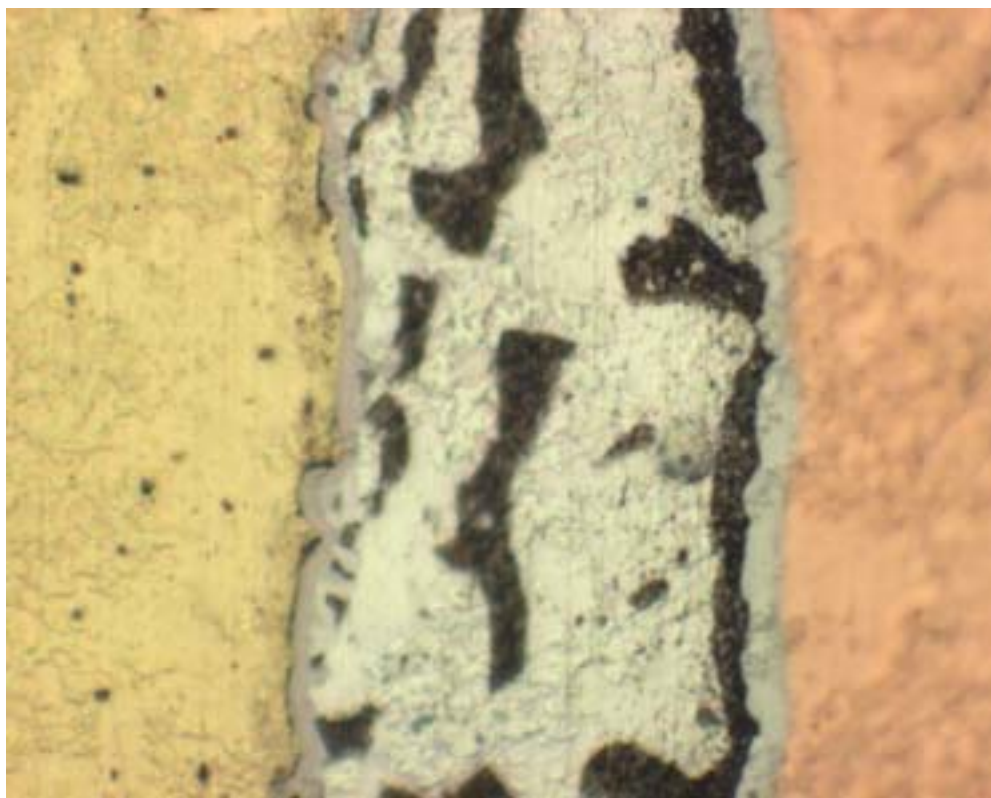
Intermetallic layer of SnPb / Cu after 2200 cycles

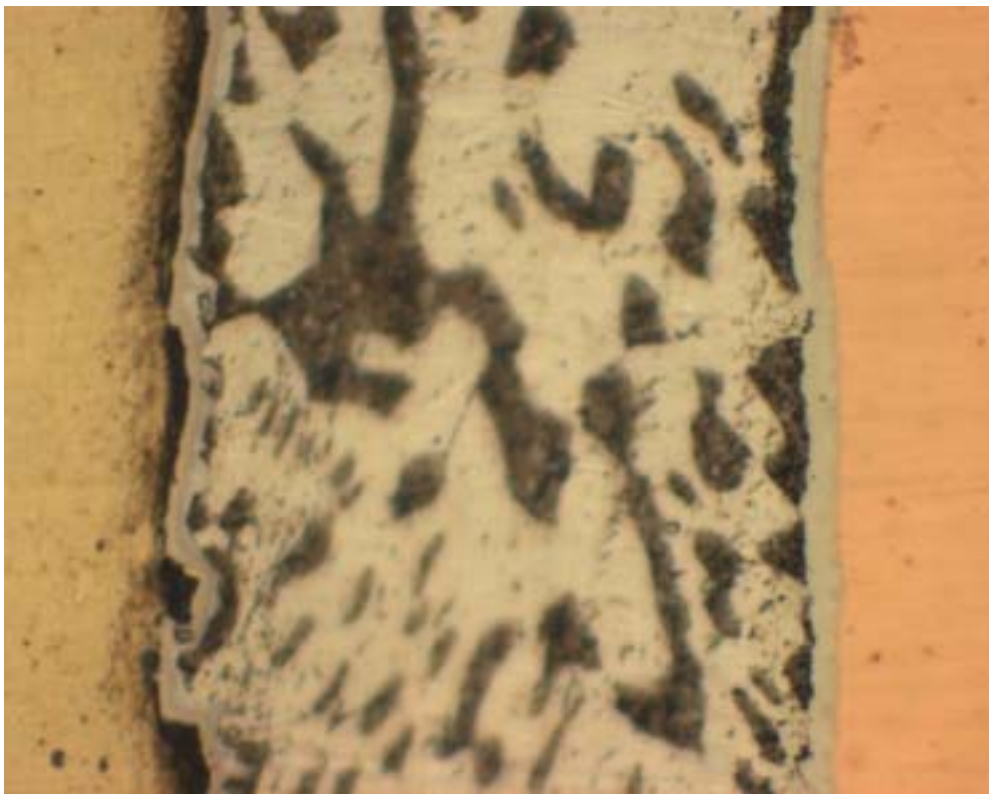
Intermetallic layer of SnPb / Sn after 2200 cycles

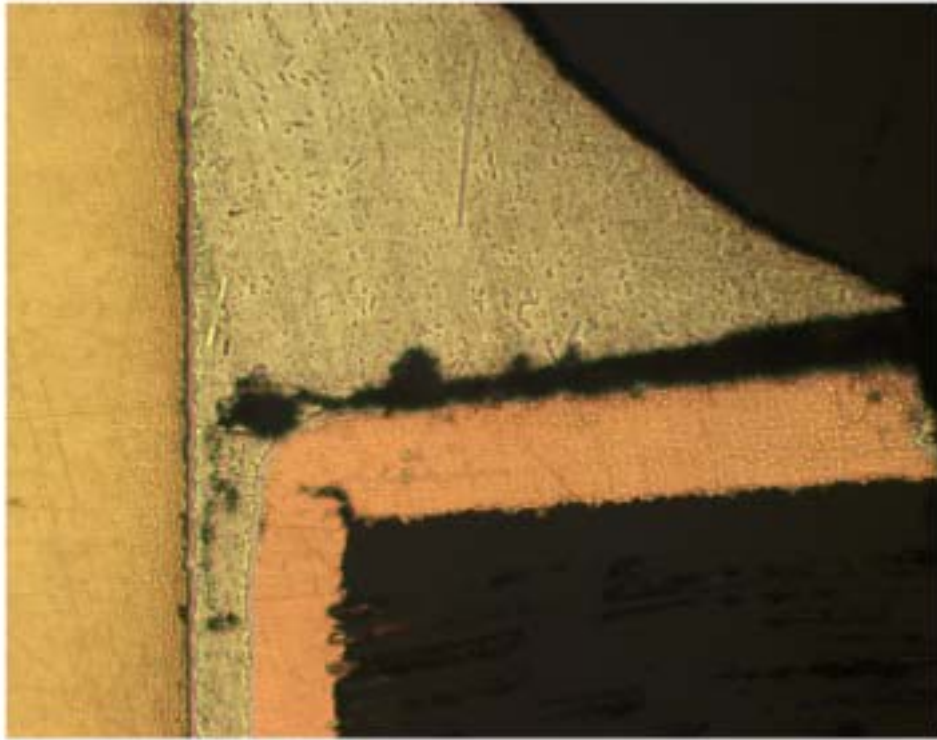
Fillet of SnAgCu / Cu after 1000 cycles

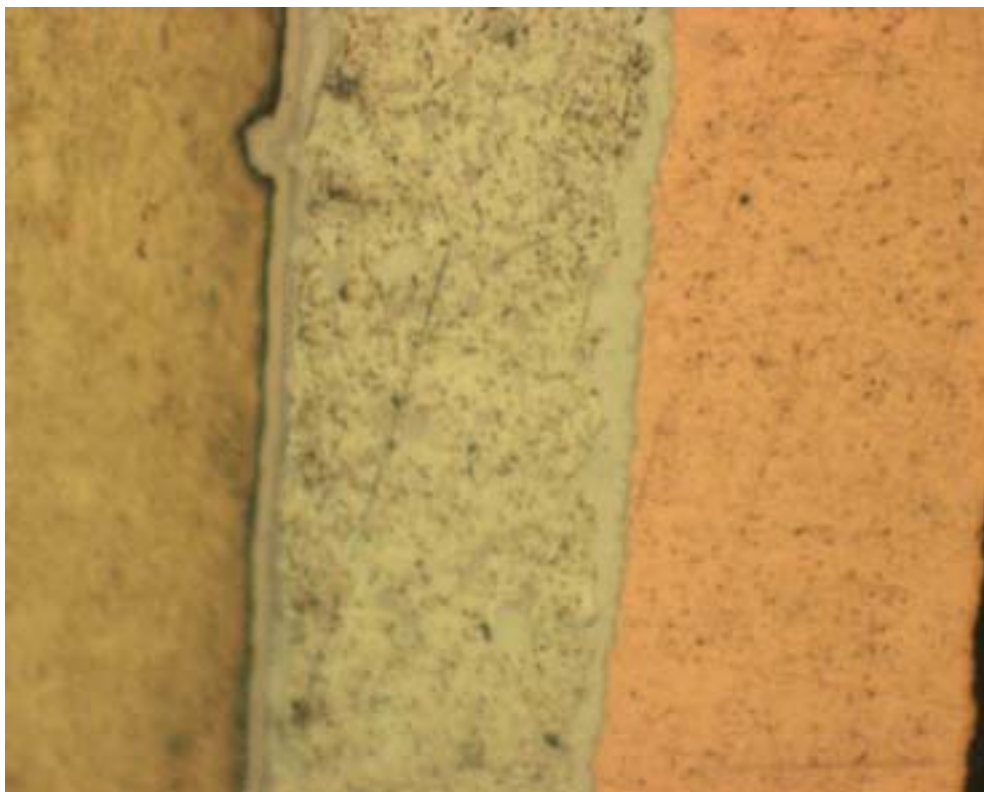
Intermetallic layer of SnAgCu / Cu after 1000 cycles

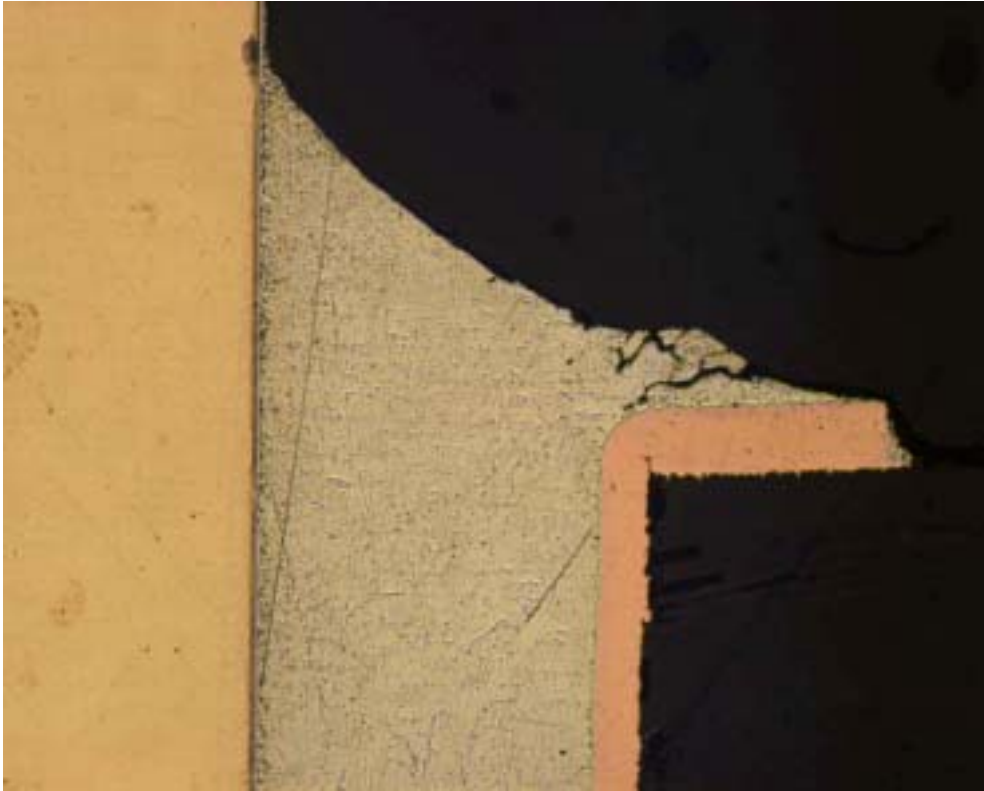
Fillet of SnAgCu / HASL after 2200 cycles

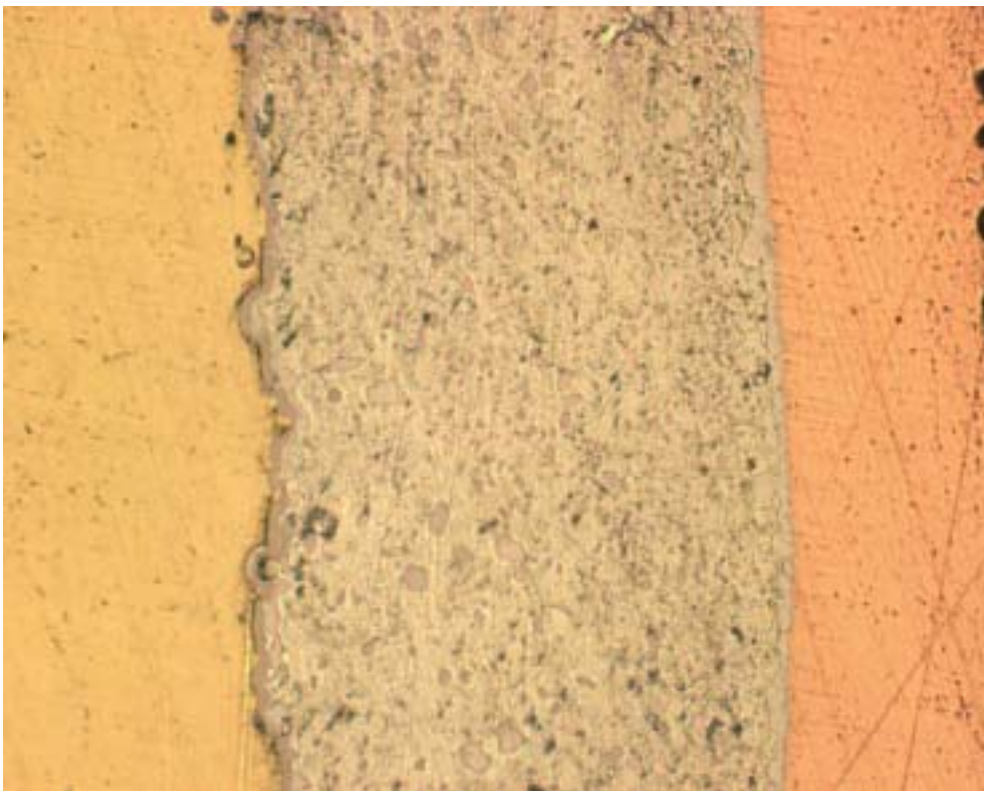
Intermetallic layer of SnAgCu / HASL after 2200 cycles

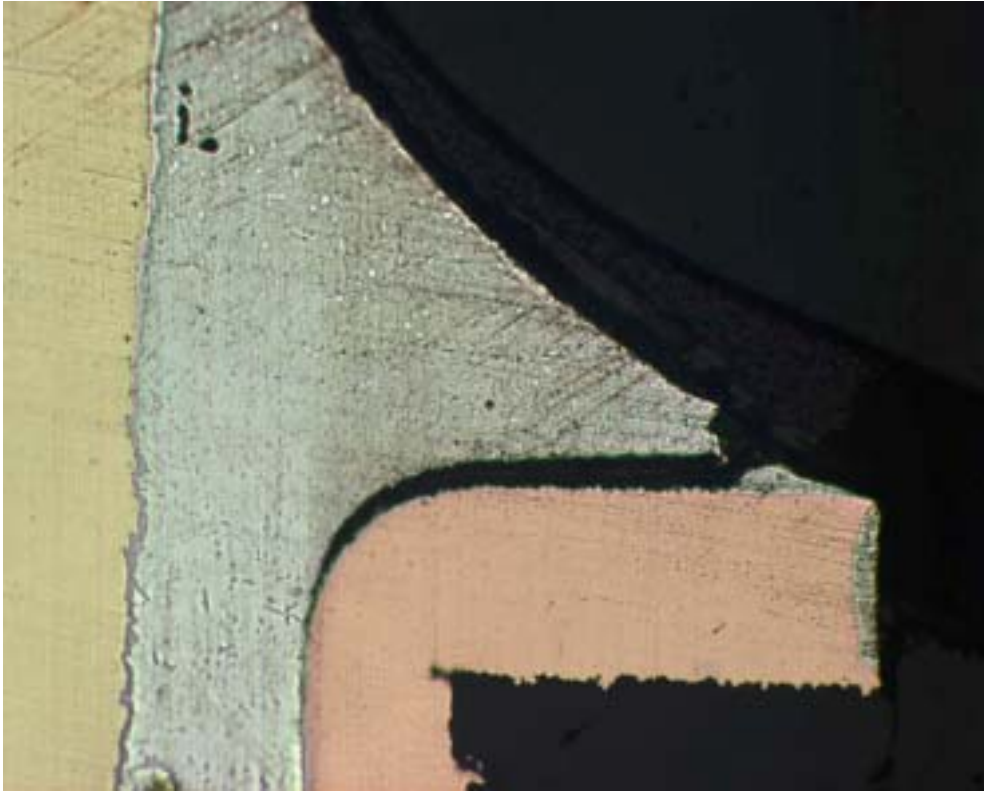
Fillet of SnAgBiCu / Cu after 400 cycles

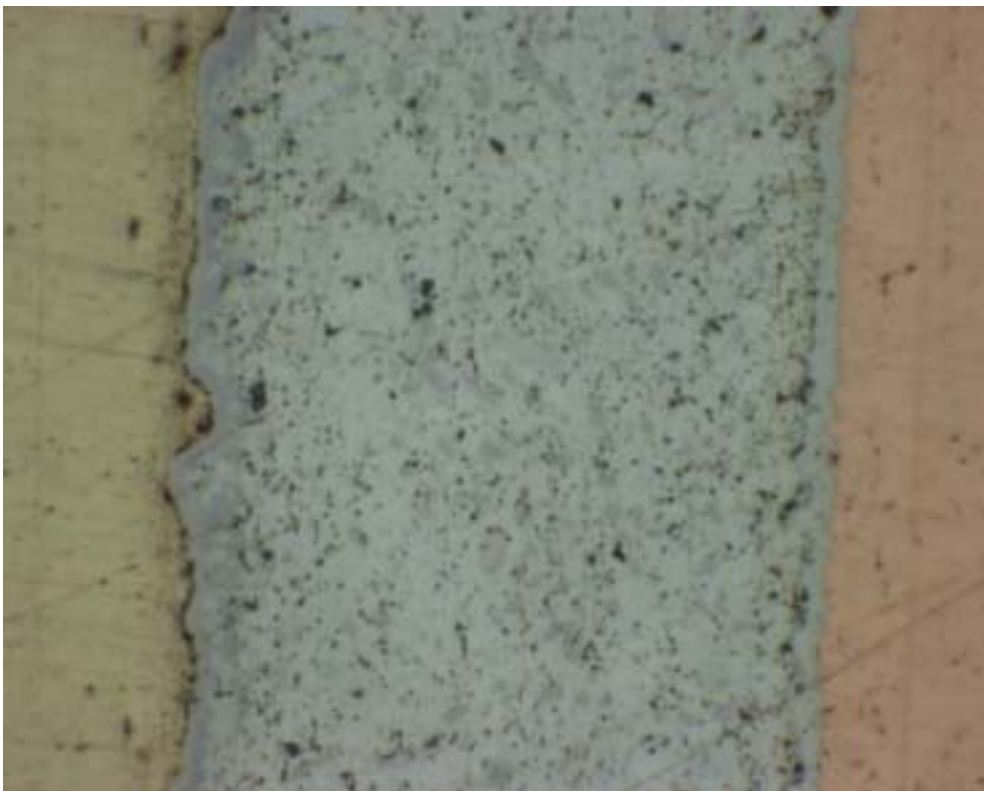
Intermetallic layer of SnAgBiCu / Cu after 400 cycles

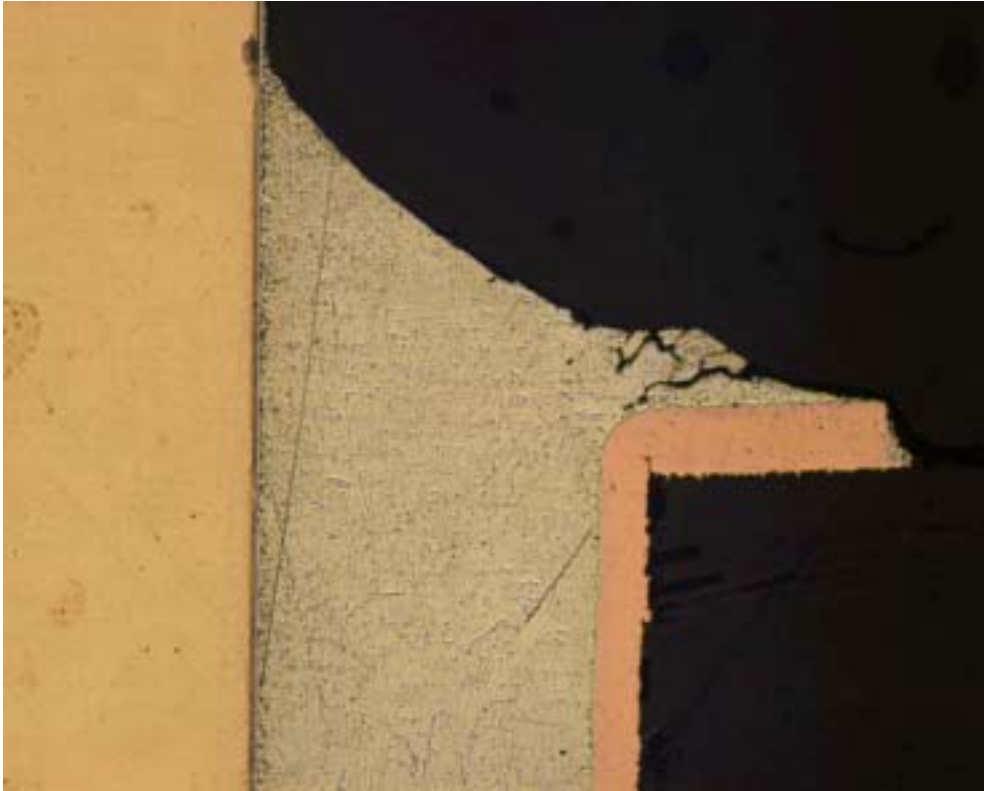
Fillet of SnAgBiCu / HASL after 1000 cycles

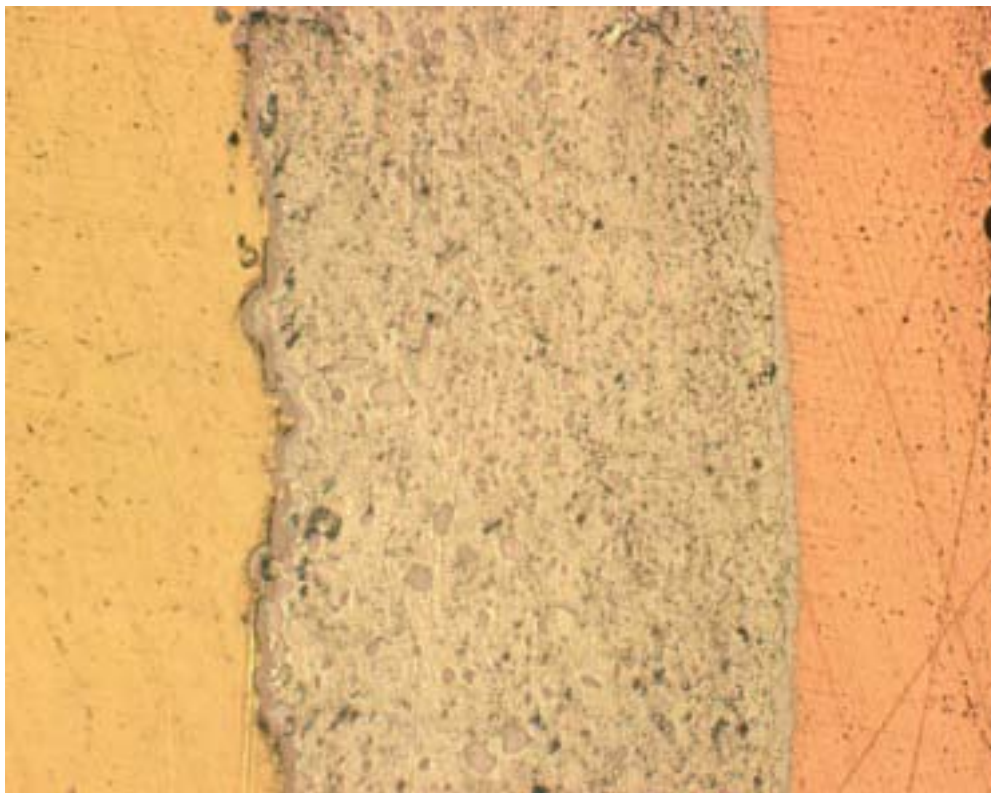
Intermetallic layer of SnAgBiCu / HASL after 1000 cycles

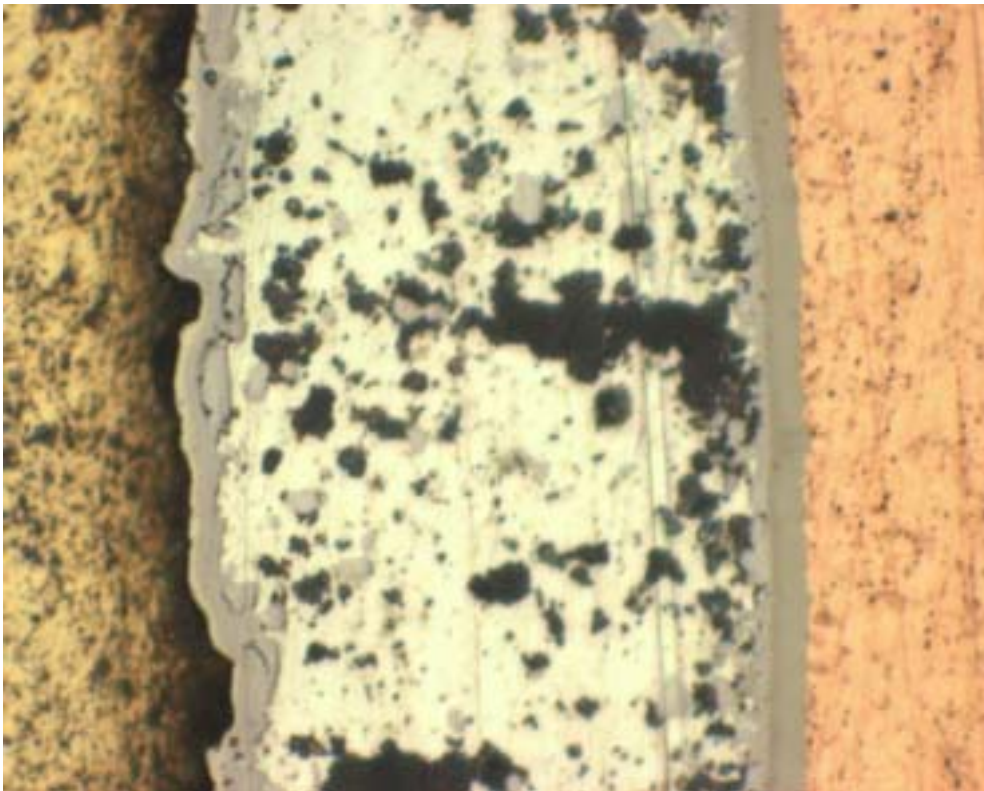
Intermetallic layer of SnAgBiCu / AuNi after 2200 cycles
