# **An Evaluation of Thermal Barrier Coated Specimens Exposed to Long-term Ageing Tests**

S R J Saunders, and J P Banks  
Materials Centre  
National Physical Laboratory  
Teddington, Middlesex, UK, TW11 0LW

## **ABSTRACT**

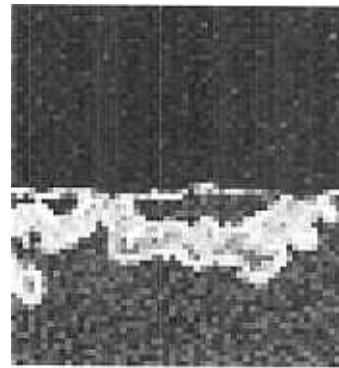
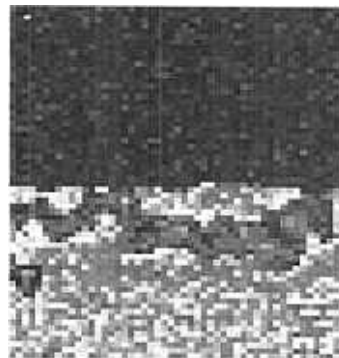
**Figure 12** *Scanning electron micrograph of a cross-section of a blade taken from service with the corresponding Al and Cr digimaps and the fluorescent stress map and associated intensity of the boxed area*

The alumina layer formed during ageing may become less protective and one consequence might be that the TGO becomes enriched in chromium. It is unclear how the increasing chromium content would manifest itself in the fluorescence spectra. There is evidence in the literature [10] that the intensity increased up to a maximum at about 1 wt% Cr and thereafter decreased, while there is a linear increase in  $R_2$  shift with increasing chromium content. Thus the effect of build-up of chromium in the TGO layer is of interest, and several cases were observed during examination of the cross-sections of the aged specimens and in an examination of cross-section of used blades. Figure 12 shows an example of the SEM examination of these samples together with the associated residual stress and intensity maps.

The stress map suggests that the TGO has close to zero stress, but care in interpretation is required since the TGO contains significant amounts of chromium as indicated by the digimap. It is also of interest to note that in the region of the TGO where the Cr concentration is high the intensity of the signal has decreased suggesting that the concentration is greater than 1 wt %.
