## NPL REPORT MAT 36

### Evaluation of the Ability of Conformal Coatings to Inhibit Tin Whiskering

**M WICKHAM and C HUNT**

SEPTEMBER 2009

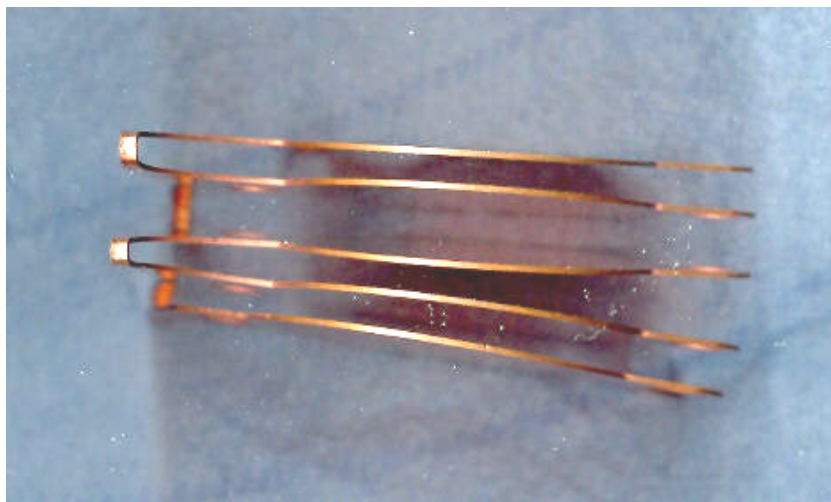
After appropriate plating and conformal coating, the etched sheets are concertinaed so that the discs became parallel as shown in Figure 3. Two such sheets were then assembled together so that an arrangement of alternate interconnected parallel plates was achieved. The interconnecting arms for each set of plates were assembled on opposite sides to ensure that only the circular plates are overlapping.

**Figure 3: Folded sheet**

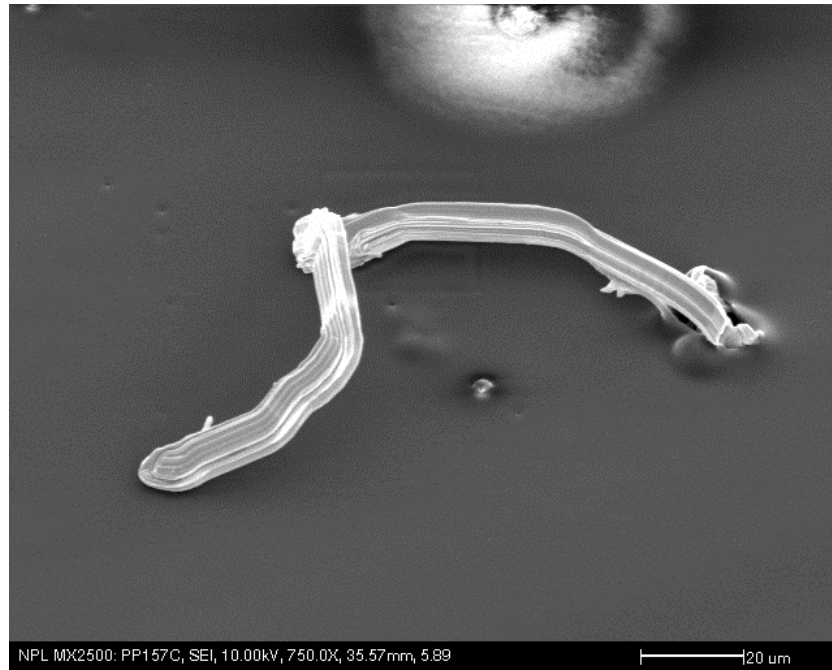
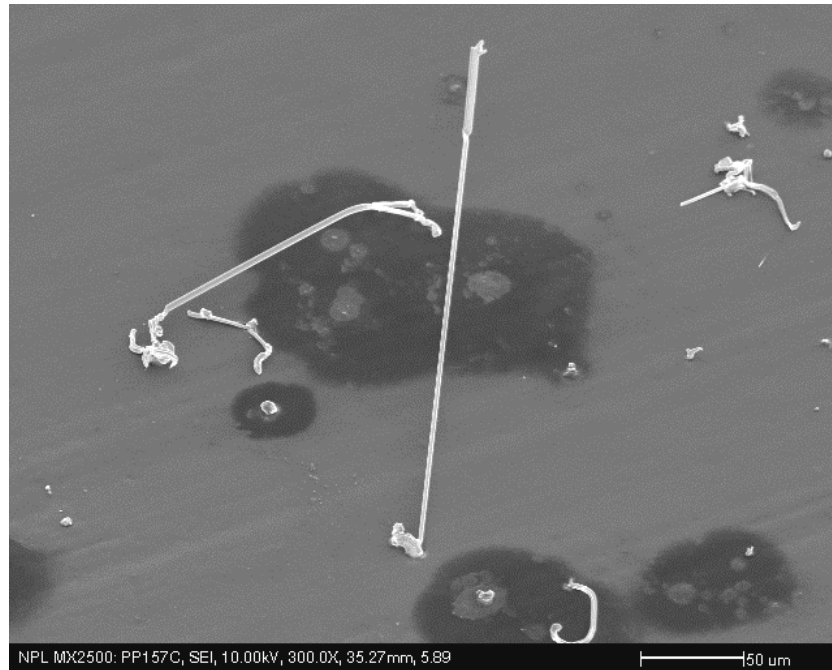
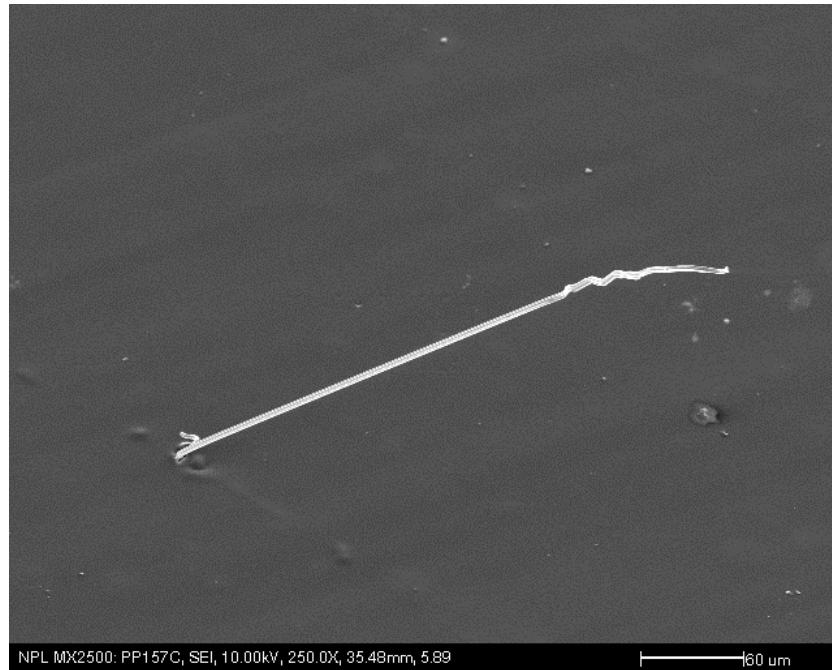
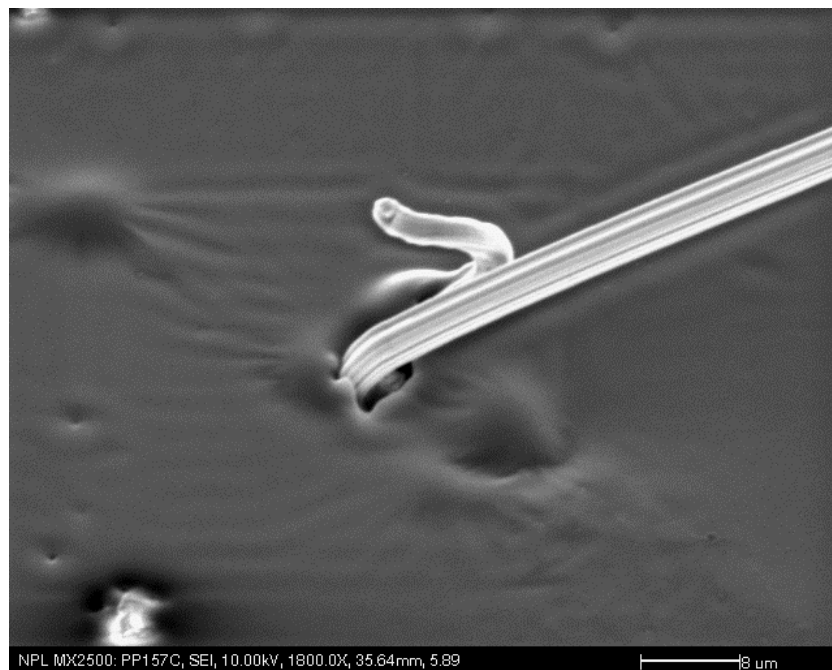
A summary of performance of the four acrylic conformal coatings is given in Table 4. All coatings developed shorts/intermittents and edge whiskers during testing. Typical edge whiskers are shown in Figure 13. Two materials exhibited whiskers erupting through coating. Typical erupting whiskers can be seen in Figure 14 to Figure 20.

**Figure 14: Typical erupting whisker (~150 μm in length) on acrylic sample.**

**Figure 15: Typical erupting whisker (~200 μm in length) on acrylic sample.**

**Figure 16: Typical erupting whisker (~250 μm in length) on acrylic sample.**

**Figure 17: Root of erupting whisker shown above**

**Figure 18: Typical erupting whisker (~300  $\mu\text{m}$  in length) on acrylic sample.**

**Figure 19: Root of erupting whisker shown above**

**Figure 20: Typical emerging whisker (~20 $\mu$ m in length) on acrylic sample**
