**NPL REPORT MAT 38**

**Reliability of Electronic  
Substrates After Processing  
at Lead-free Soldering  
Temperatures; Part 2**

**M WICKHAM, C HUNT,  
B BIRCH and J FURLONG**

**MARCH 2010**

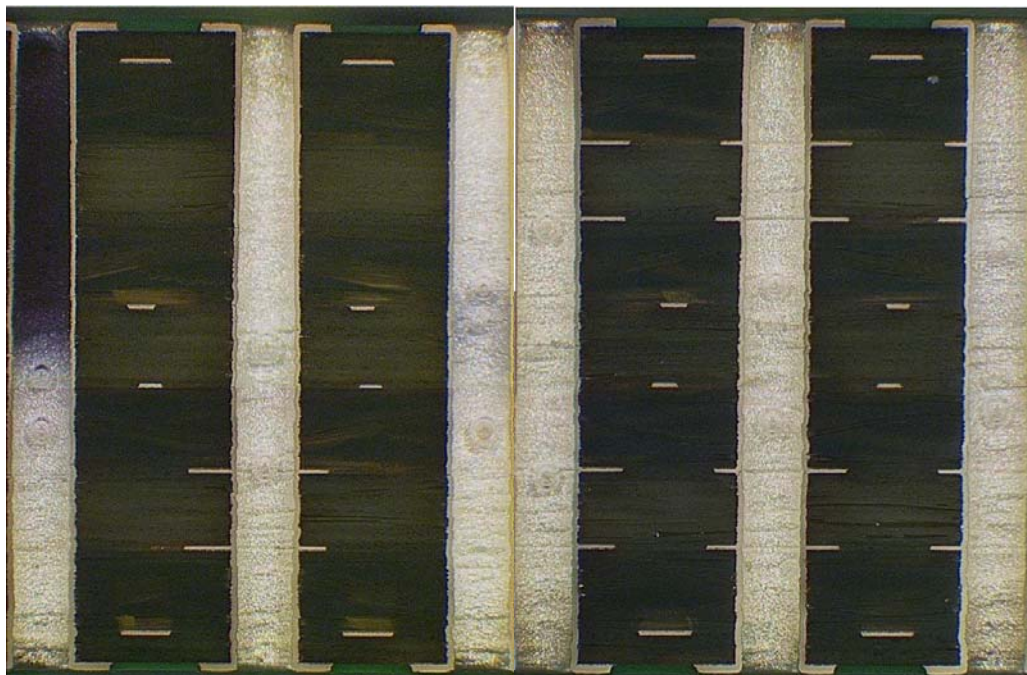
**Figure 4: Micro-sections of thermally cycled vias showing non-functional pads excluded (left) and included (right)**

As the each test substrate incorporated test structures for both the inclusion and exclusion of non-functional pads (as shown in Figure 4), variances in the via wall thickness are not relevant and a direct comparison of results can be undertaken. The failures that were generated during thermal cycling for samples where non-functional pads were included or omitted, are shown in Figure 5, as a Weibull plot. The plot shows similar gradients for both sample sets but where non-functional pads were removed, the time to failure is greater than that for samples with the non-functional pads included. The number of cycles to 50% failures is around 700 thermal cycles when the non-functional pads included, compared to around 930 thermal cycles when the non-functional pads are removed.

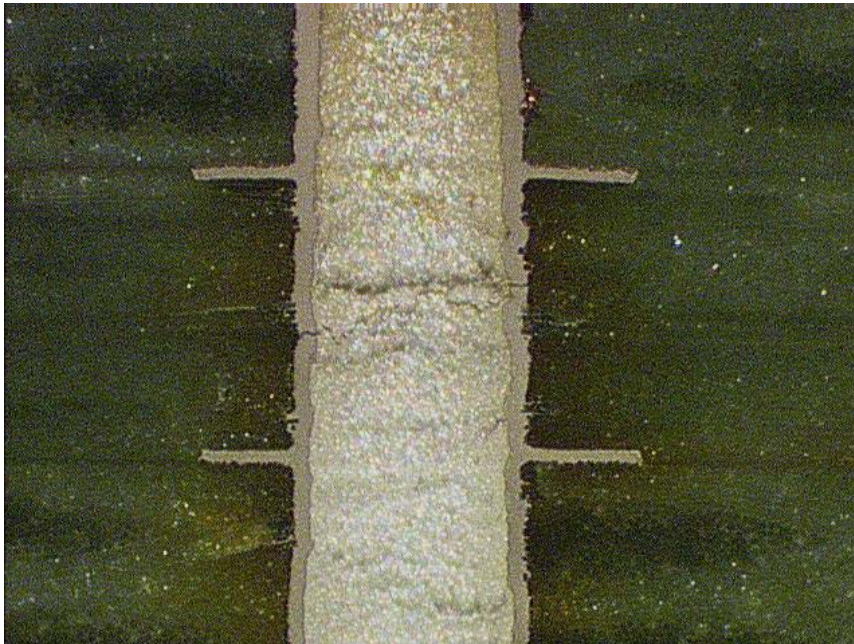
**Figure 8: Micro-section of via with failure in region where non-functional pads have been retained.**

Reviewing micro-sections of failed vias indicates a high percentage of vias with non-functional pads included, failed adjacent to the non-functional pads as shown in Figure 8, even though these are away from the central portion of the via, where failures would generally be expected to occur. This correlates well with other evaluations that have been undertaken by PWB (reference 4) and Kim et al (reference 1). It has been postulated that the inclusion of non-functional pads in high aspect ratio vias acted as stress concentrators, leading to the earlier failure.
