**A Comparison Of  
Automatic Optical  
Inspection Systems For  
Use With Lead-Free  
Surface Mount  
Assemblies**

**M Wickham & C Hunt**

**July 2002**

Materials Centre  
National Physical Laboratory  
Teddington, Middlesex, UK, TW11 0LW

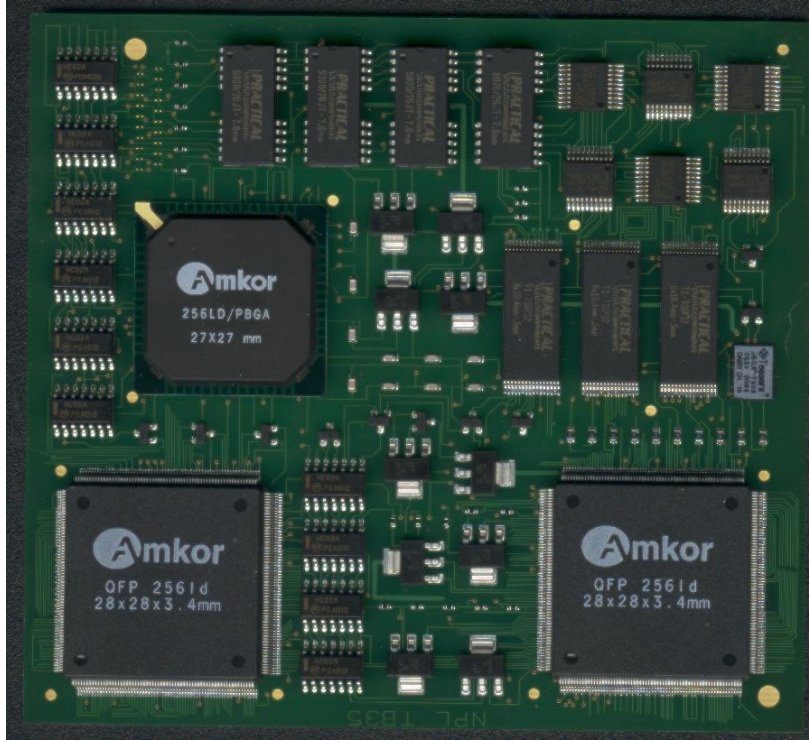
**Figure 1 : Test Assembly**

The test assembly comprised a single-sided PCB containing 87 surface mount (SM) components, as shown in Figure 1 and detailed in Table 1. Twelve different component styles were incorporated with over 1400 solder joints on each assembly.

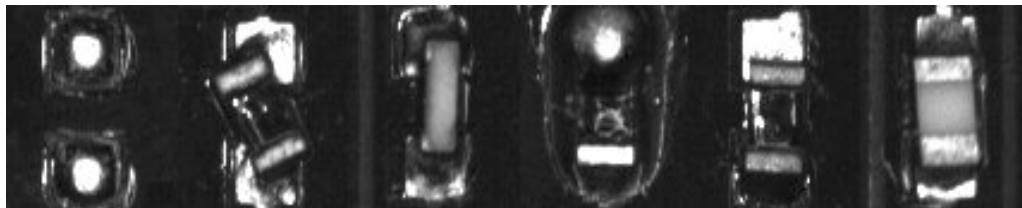
**Figure 7 : Images of R0402 defects (from left to right - missing, misalignment, component on edge, excess, insufficient, inverted (source : Agilent))**

Table 15 again highlights a spread of performances with only system F not incurring a low rating in its responses. This system was also the only system to achieve high confidence for all defect categories. Of the occurrences of low ratings, two of these were for inverted components, which could probably be improved by better programming, and is a defect classification considered by many end users as not important enough to report. Similarly, several systems achieved only low ratings for excess solder joints, a defect category which has a low occurrence in production assemblies. It is encouraging that all the systems achieved medium or high ratings for locating the “insufficient defects” on these components. No trends could be detected in the relative performances of the line scanner, vertical camera or angled camera systems. Figure 7 shows images of some of the R0402 defects from the benchmarking assemblies. No comparison with the results from the previous NPL AOI benchmarking project (Reference 1) using SnPb solder joints was possible as the assembly used for that evaluation did not include any R0402 components.
